Dolphin – DB 274569 – Fraser White

Inspection carried out by Keith Bowers and John Wight.

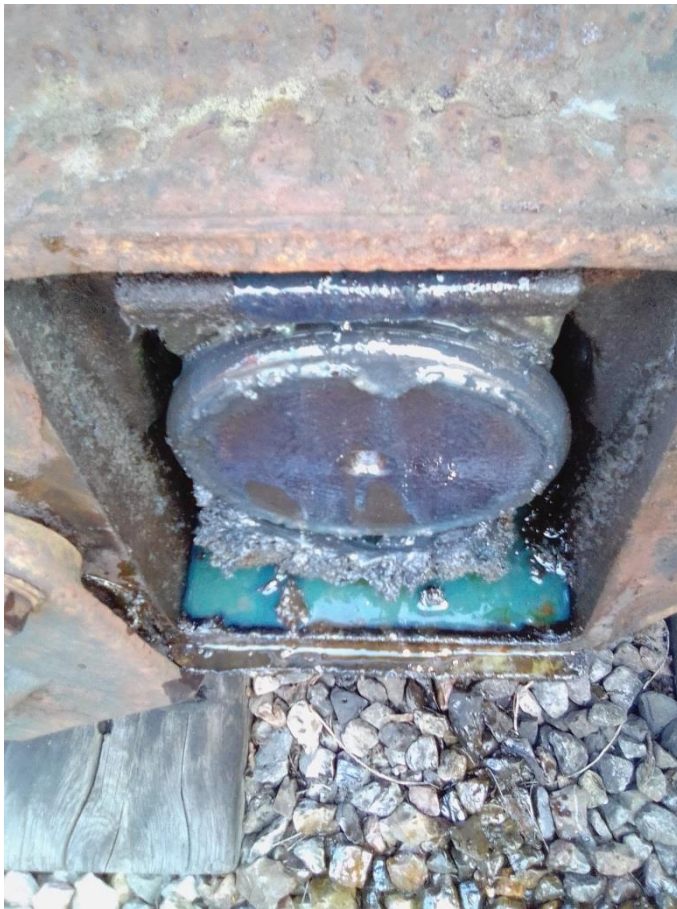
In the axlebox which is the second closest to Wareham and on the down side, the top of the bearing projects outwards and rubs on the ridge at the axle end. In all other axleboxes there is approximately a 3/8in gap. This bearing may be outside of its normal position. This box is marked with a yellow cross.
